**“Contingency Management in water
supply systems –
The EPAL´s Experience”**

EPAL

Alexandra Cristóvão
W-SMART Workshop
Amsterdam 03-04.11.2017

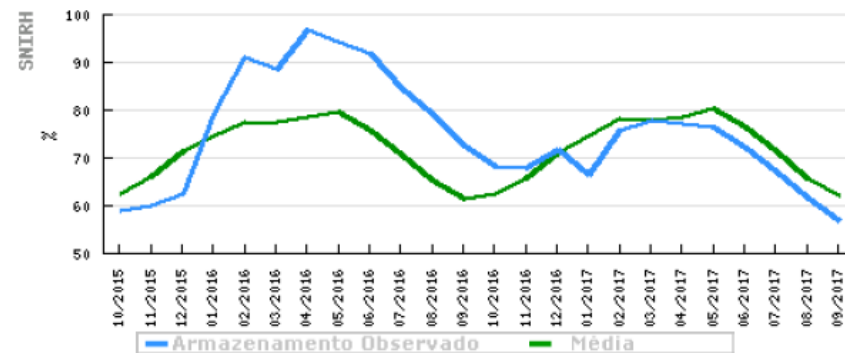
Evolução do Armazenamento nas albufeiras da Bacia TEJO em Setembro

Evolução do armazenamento na Bacia TEJO.

Volumes Armazenados (10^6 m^3)

Percentagem (%)

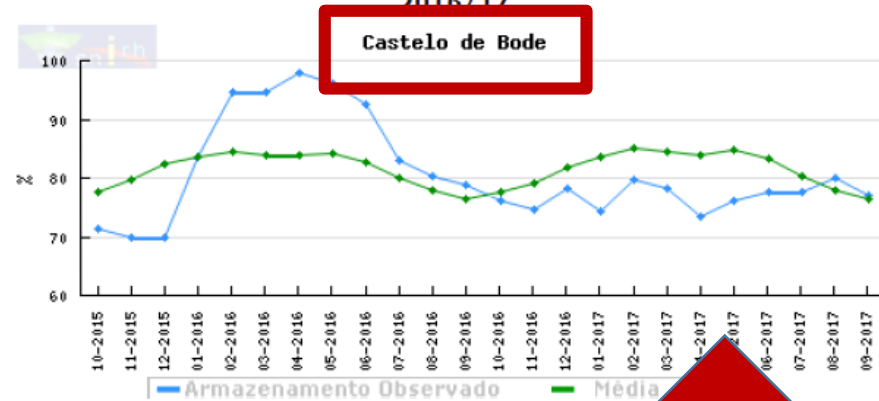
evolução do armazenamento da Albufeira de nos Anos Hidrológicos 2015/16 e 2016/17

Volumes Armazenados (10^6 m^3)

Porcentagem (%)

Linha de Água: RIO ZÉZERE

Uso Principal: Abastecimento

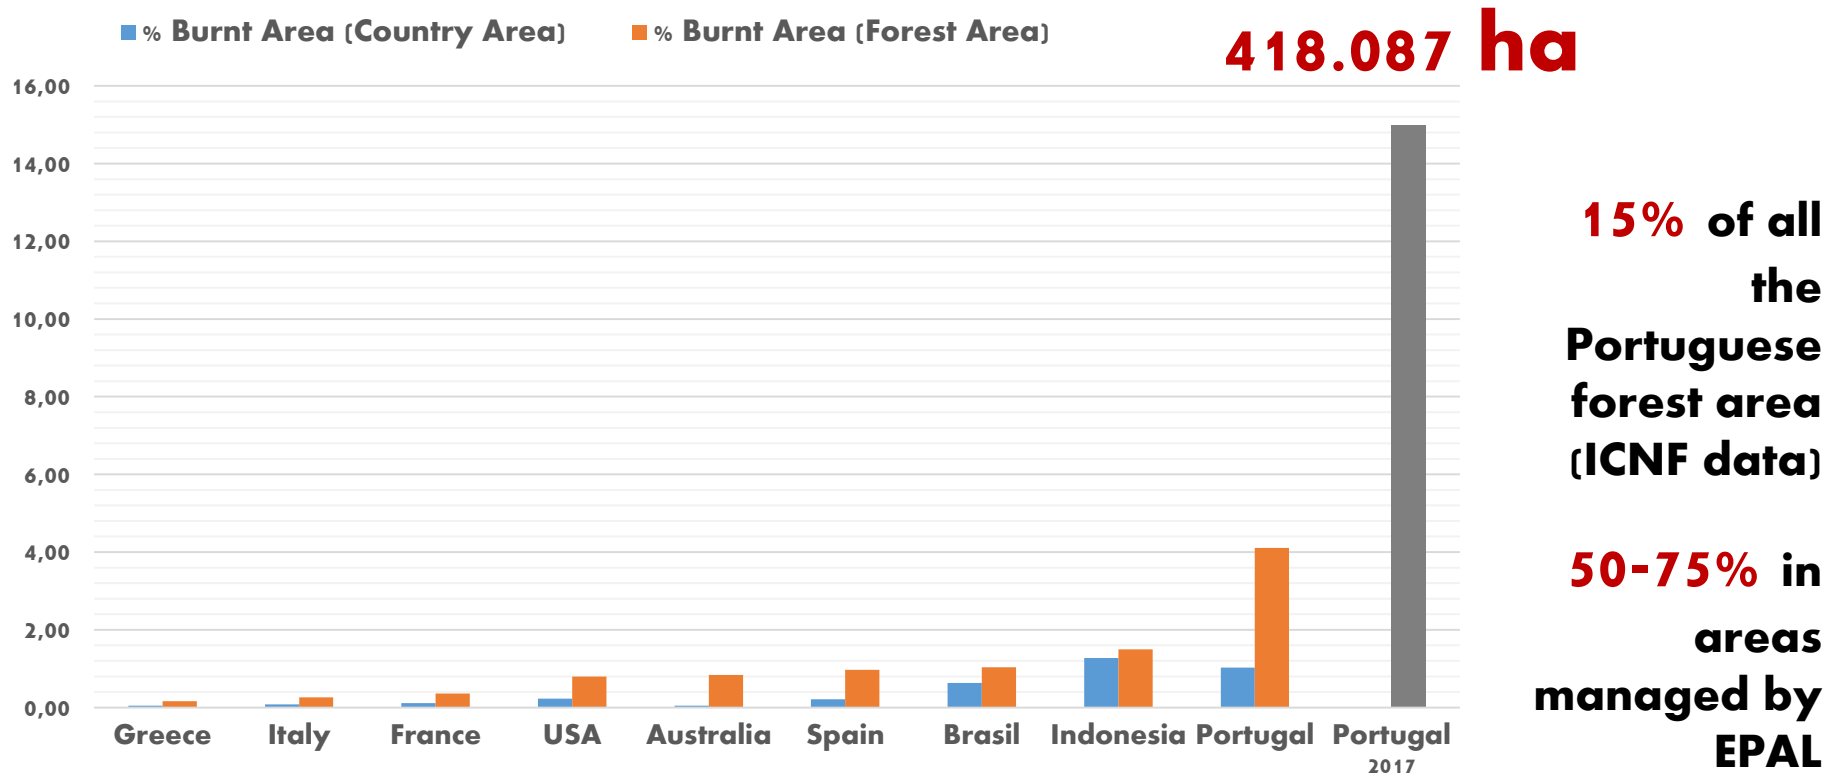
Sources: Global Forest Watch – 2016; ICNF - 2017

According to Global Forest Watch Portugal lost 4% of its forest area in 2016, accounting for 1/2 of the burnt forests in the European Union.

The Institute for Forests and Nature Conservation (ICNF) counted, until the 16th of October, 418.087 hectares of forest destroyed by fire, this year.

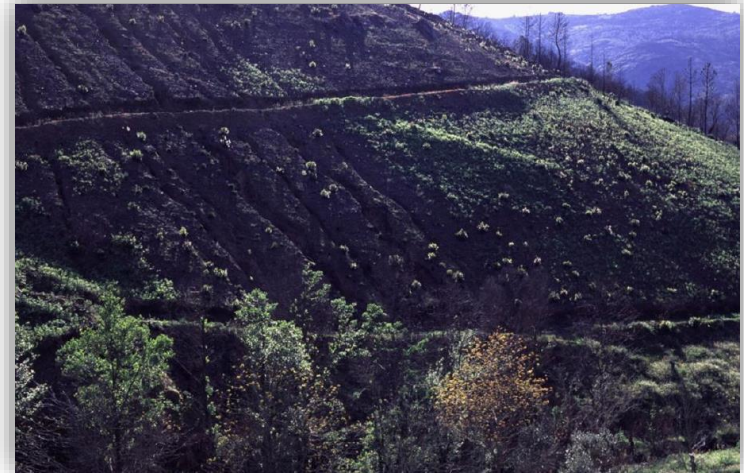
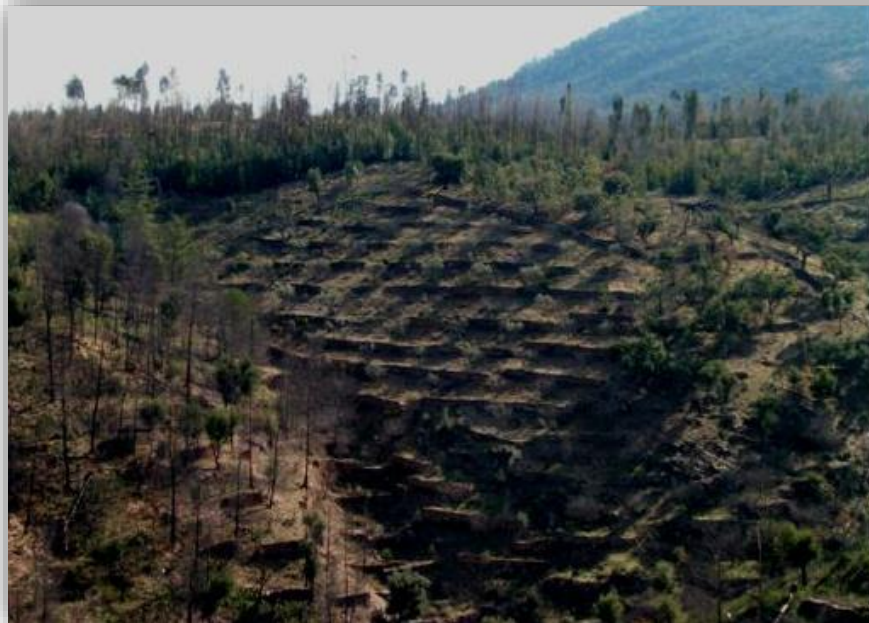
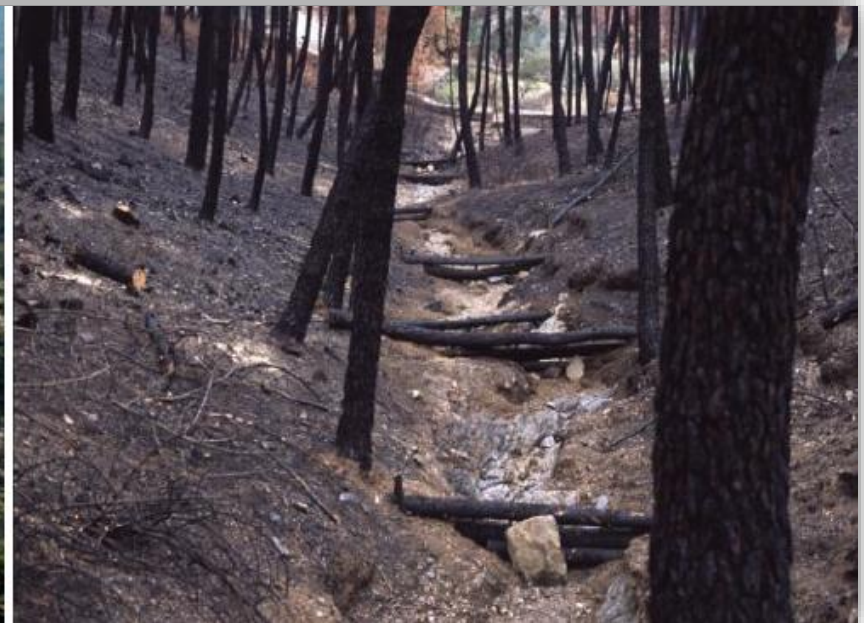
Preventing soil erosion in burnt areas

- **Contacts with official entities and NGO´s to participate in the definition and implementation of measures in order to prevent soil erosion in the burnt areas:**
 - **Creating carpets with vegetable waste;**
 - **Creating trenches;**
 - **Creating natural barriers with burnt logs.**
